REPORT OF THE CHIEF INSPECTOR OF SAFETY APPLIANCES  
COVERING HIS INVESTIGATION OF AN ACCIDENT WHICH  
OCCURRED ON THE SOUTHERN RAILWAY NEAR OYAMA, N. C.,  
ON MARCH 31, 1913, ACCOMPANIED BY REPORT OF THE ENGI-  
NEER-PHYSICIST OF THE BUREAU OF STANDARDS COVERING  
HIS INVESTIGATION OF THE BROKEN RAIL CAUSING THIS  
ACCIDENT.

JANUARY 7, 1914.

## REPORT OF THE ENGINEER-PHYSICIST.

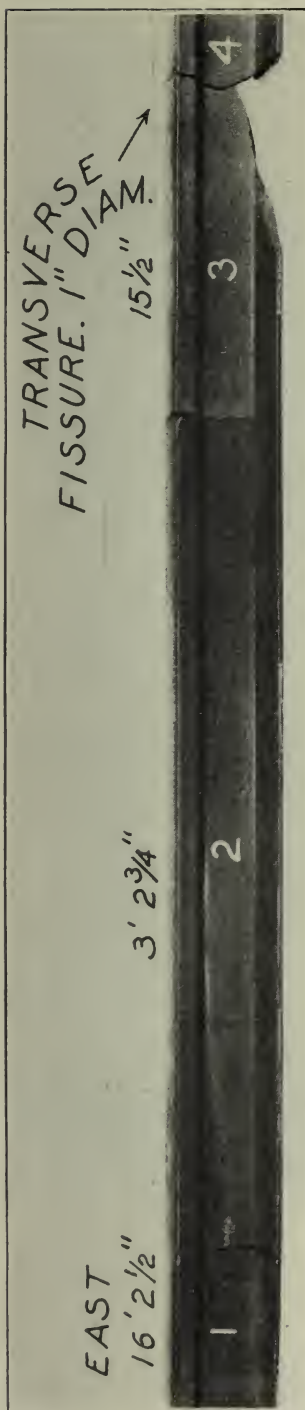
The receiving ends of fragments Nos. 1 and 2 were bruised and depressed with reference to the direction in which train 3d No. 72 passed over the track, which establishes their priority over those believed to have been caused by the wrecked train No. 73. The bruises on the other fragments faced the direction in which the wrecked train moved, and were clearly secondary with respect to those first mentioned. From the testimony it appears that the track had been made practically new within a period of 17 months, and was in first-class condition, so far as known. Under such conditions there would be a reasonable opportunity for a slow-moving freight train successfully to pass over a well-spiked track in which there was a rail which had been broken by the engine hauling that train.

No. 1. Easterly portion of fractured rail, gauge side; fractures 1-2 and 2-3 attributed to eastbound train No. 72.

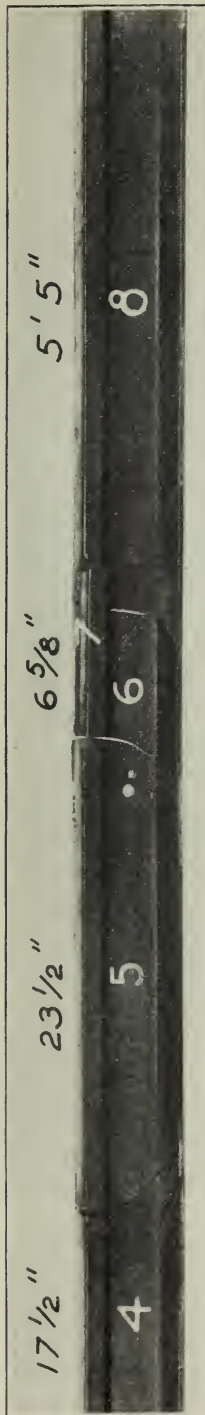
No. 2. Middle portion of fractured rail, gauge side; fractures attributed to wrecked, or westbound, train No. 73.

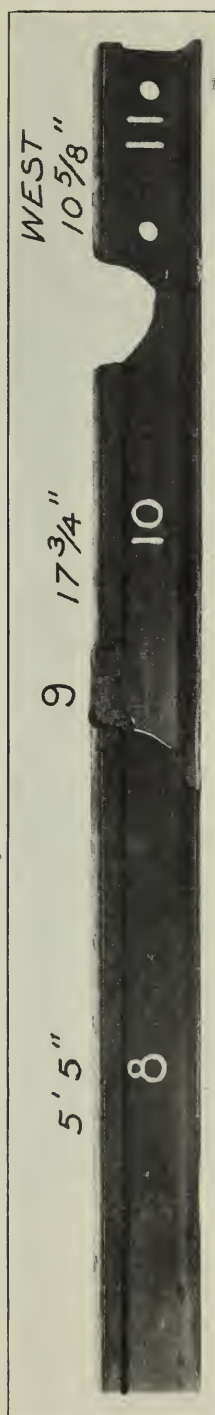
From the markings on the fragments located west of No. 3 it is evident they were caused by the wrecked train. The train drifted

No. 3. Westerly portion of fractured rail, gauge side; fractures attributed to wrecked, or westbound, train No. 73.

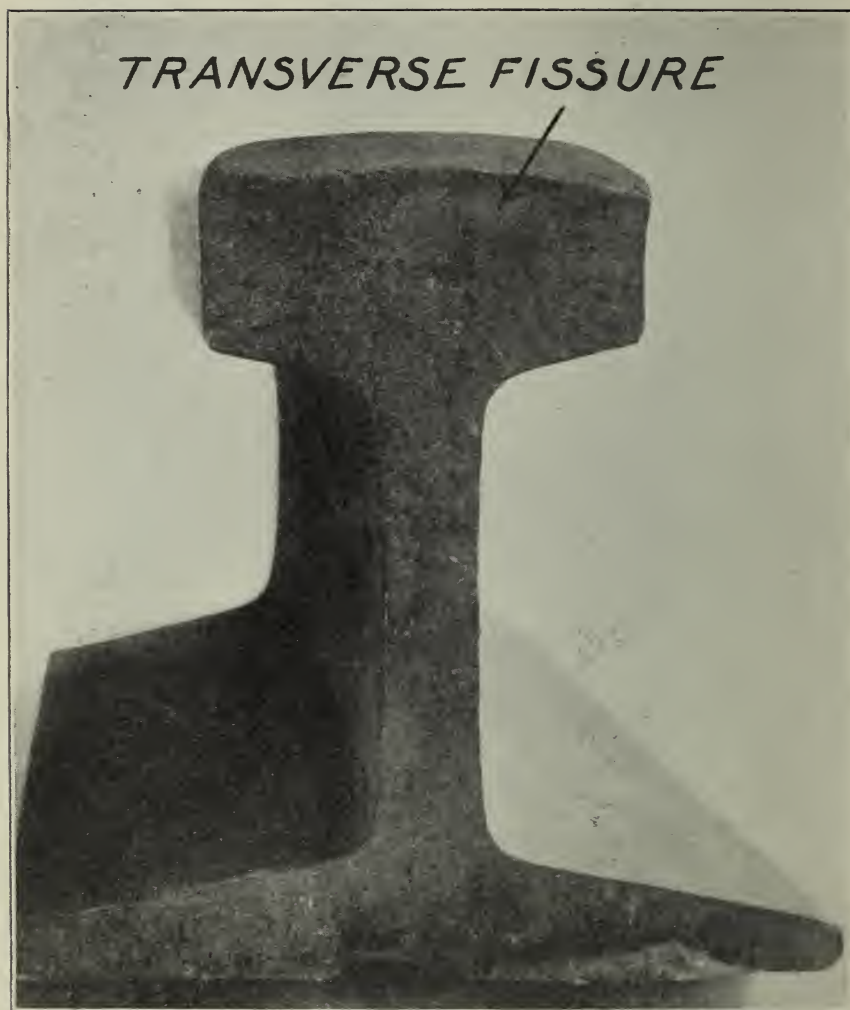
Photographic prints, reproduced in figures Nos. 1, 2, and 3, show the appearance of the fractured rail, viewed from the gauge side. A transverse fissure 1 inch in diameter was present in the head, on the gauge side, on the fractured surface between fragments Nos. 3 and 4. Figure No. 4 shows the appearance of this transverse fissure.

The fracture which was first formed is believed to have been either that between fragments Nos. 2 and 3 or that between Nos. 3 and 4. The presence of a transverse fissure, 1 inch in diameter, between Nos. 3 and 4 would suggest that line of rupture as the incipient one, and evidence found on the running surface is not inconsistent therewith. The battered condition of the abutting surfaces of Nos. 2 and 3 so far obscure their primitive appearance that it is not feasible to judge of those surfaces in respect to priority of occurrence.

No. 4. Transverse fissure, diameter 1 inch, on fractured surface of fragment No. 4.

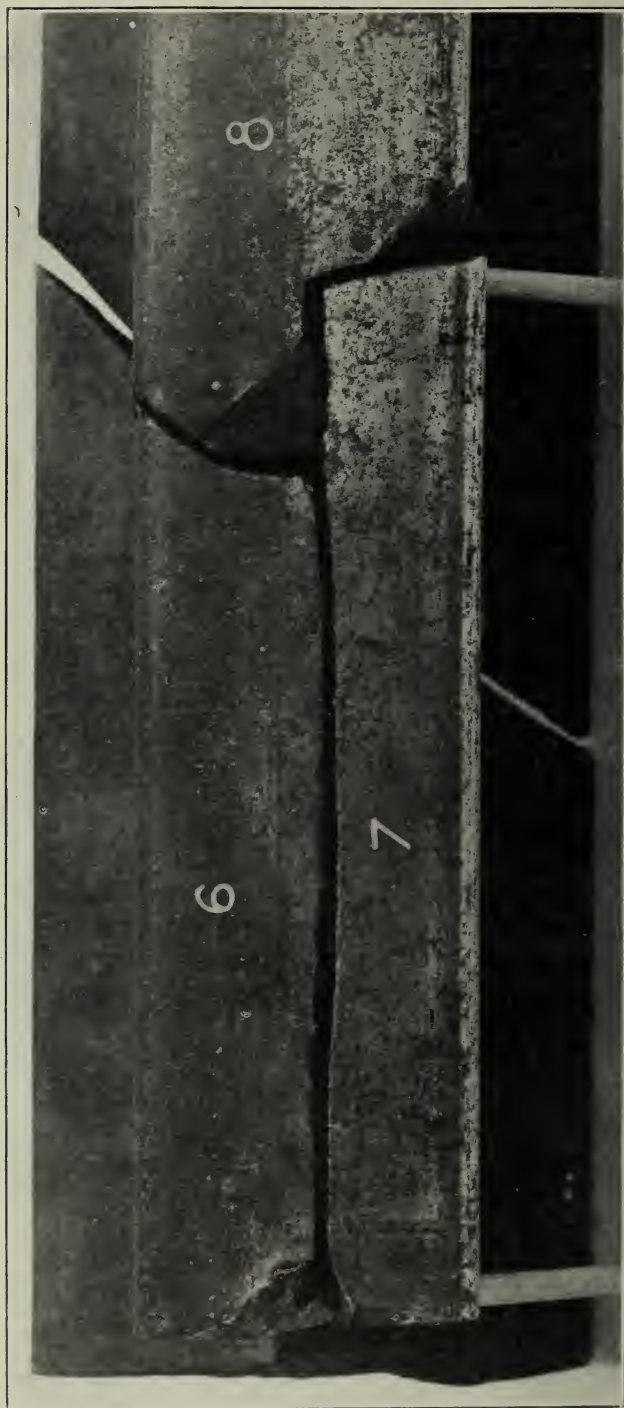
to the left and made its exit from the track, or began to do so, in the opening covered by fragments Nos. 4 to 10, inclusive. The receiving end of fragment No. 5 was much bruised and a longitudinal crack started in the head, caused by blows in part directed in an outward, oblique direction. The head of fragment No. 6, next following, was split longitudinally a length of 8 inches. The head of the rail, at the middle of its width, was struck apparently by the flange of a wheel, which acted as a wedge to split this short fragment. Figure No. 5 shows the appearance of the split head, detaching pieces Nos. 6 and 7, and also shows the battered end of No. 8.

No. 5. Split head, separating fragments Nos. 6 and 7, and battered end of No. 8.

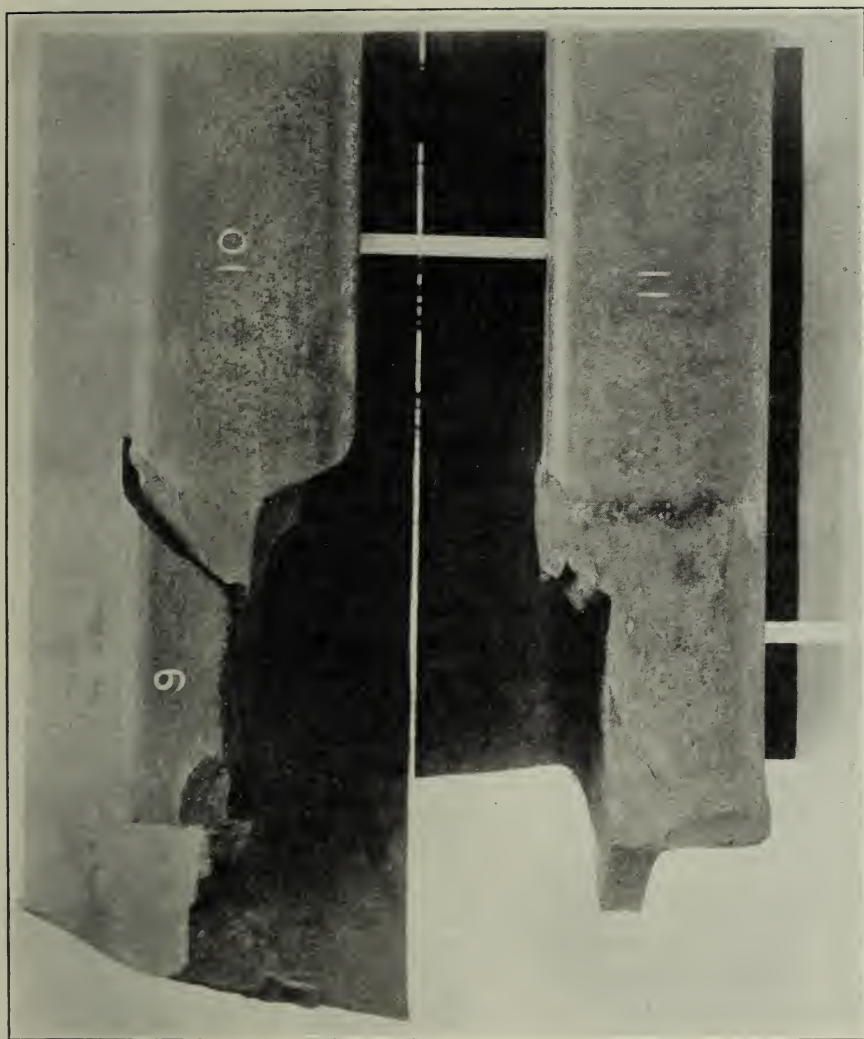
Further effects of this kind were exhibited by fragments Nos. 9, 10, and 11, shown by figure No. 6. Glancing blows were received by the rail head corresponding in direction to that taken by the wrecked train in leaving the track. In these views, looking down upon the head of the rail, the gauge side is the lower side in the figures.

No. 6. Detached fragment No. 9, and ends of Nos. 10 and 11, battered by oblique end blows.

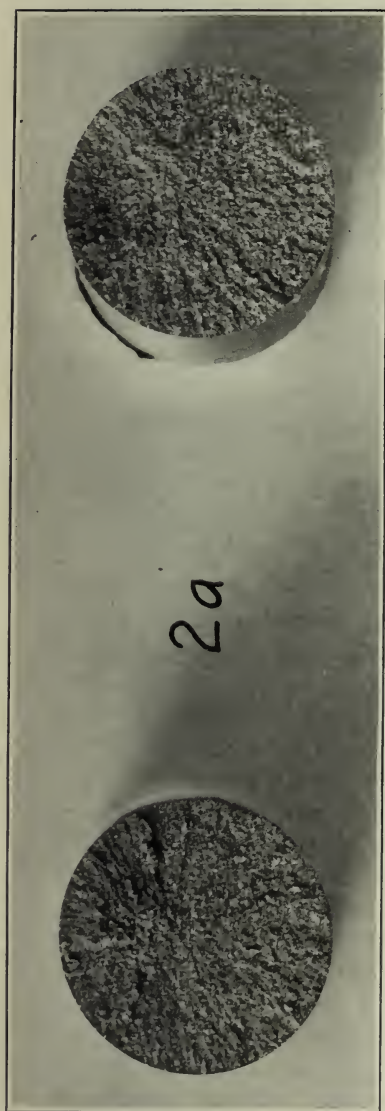
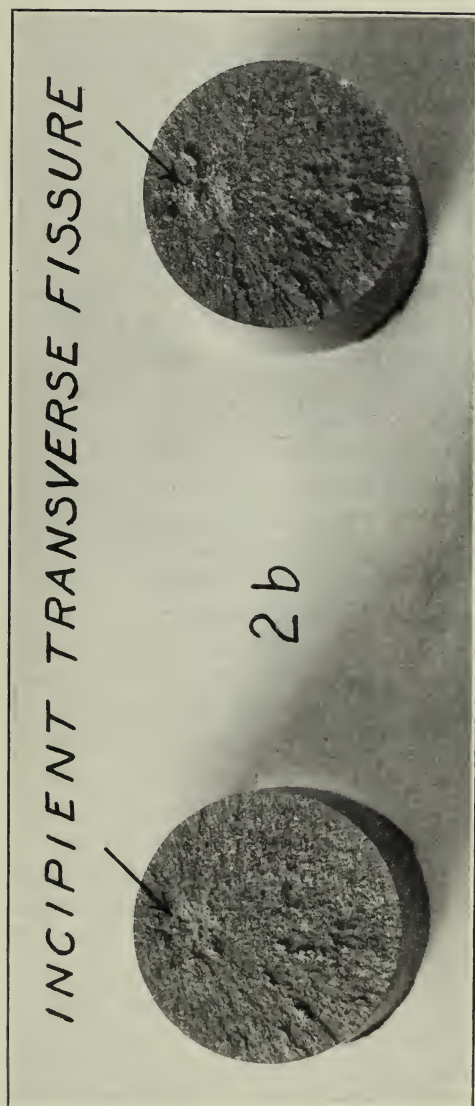
An incipient transverse fissure was disclosed in the fractured surface of the annealed specimen, the appearance of which is indistinctly shown by the upper two fractures illustrated in figure No. 7. The fissure had a diameter of 0.30 inch, a part of which possessed a bright silvery luster. This part was crescent shaped. The balance of the fissure was dull in luster and similar in appearance to the incipient place of rupture of a tensile specimen of this grade of steel. The lower two fractures illustrated in figure No. 7 represent the surfaces of the unannealed specimen.

No. 7. Fractured ends of tensile specimens 2a and 2b. A transverse fissure, diameter  $\frac{1}{8}$  inch, was disclosed in specimen 2b.

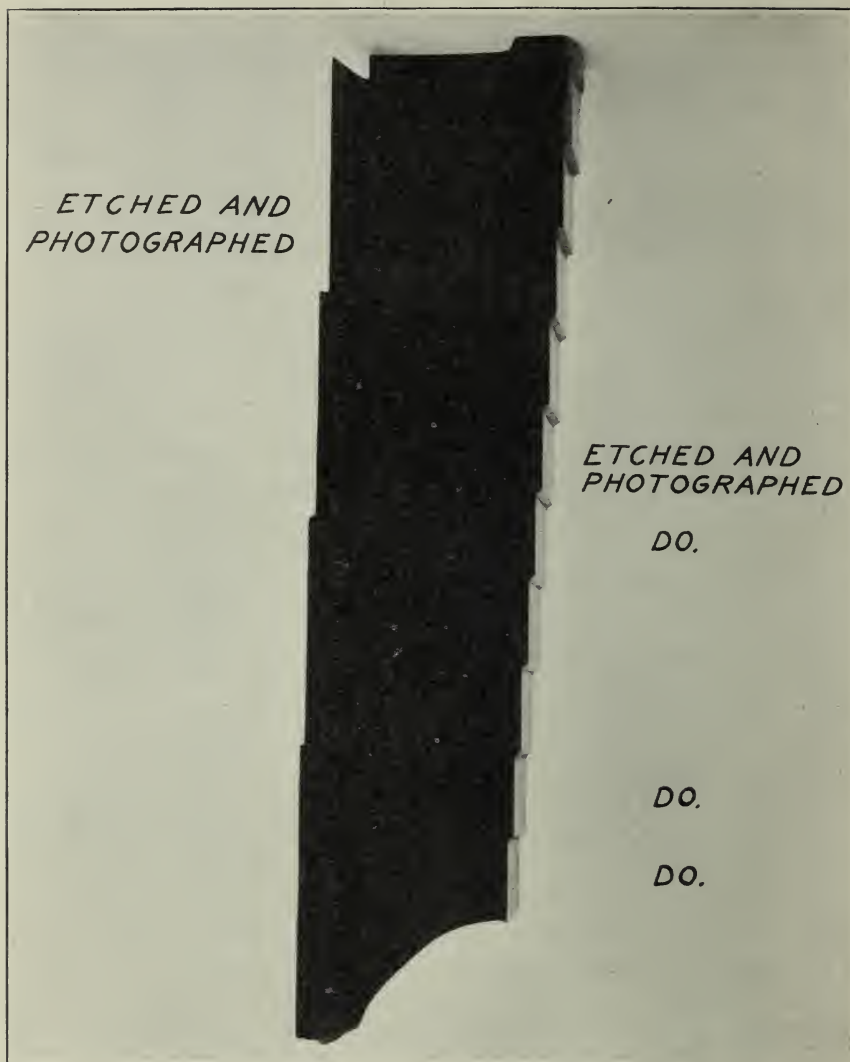
Fragment No. 4 was planed off on the head and base with steps of one-eighth inch each, as shown by figure No. 8. At each of these steps the metal was found to be streaked, rather more pronounced at depths of one-fourth inch and more in the head than nearer the surface. Photographic print, figure No. 9, shows the appearance of four sections from the head, at depths below the running surface of five-eighths inch, three-fourths inch,  $1\frac{1}{8}$  inches, and  $1\frac{1}{4}$  inches, respectively, taken from right to left. The metal was smooth polished and etched with tincture of iodine. These sections, planed down to a thickness of one-sixteenth inch, were bent transversely, and frac-

No. 8. Fragment No. 4 planed down, head and base, in steps of  $\frac{1}{8}$  inch each, disclosing streaked metal at each surface.

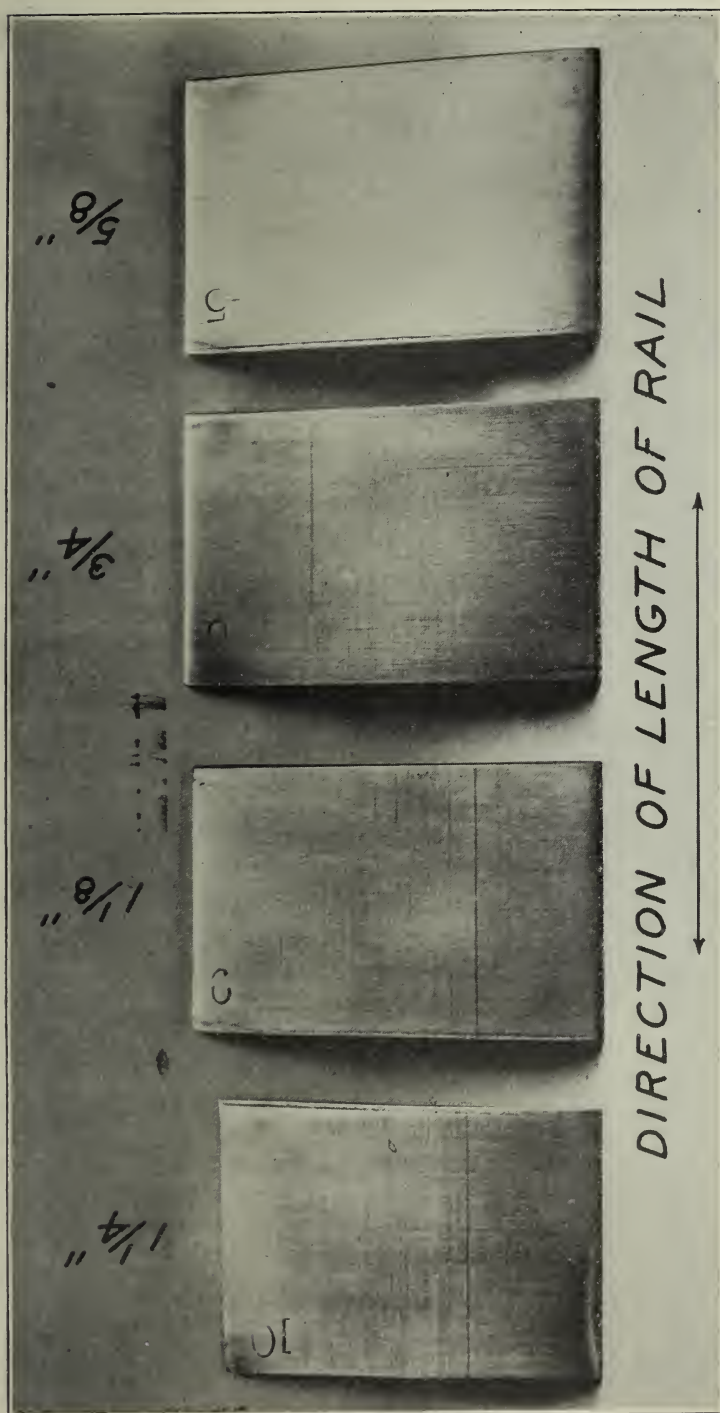
No. 9. Strips from head of rail at steps  $\frac{5}{8}$  inch,  $\frac{3}{4}$  inch,  $1\frac{1}{8}$  inches, and  $1\frac{1}{4}$  inches below running surface, as shown by figure No. 8. Surfaces polished, and etched with tincture of iodine, showing streaks in steel.

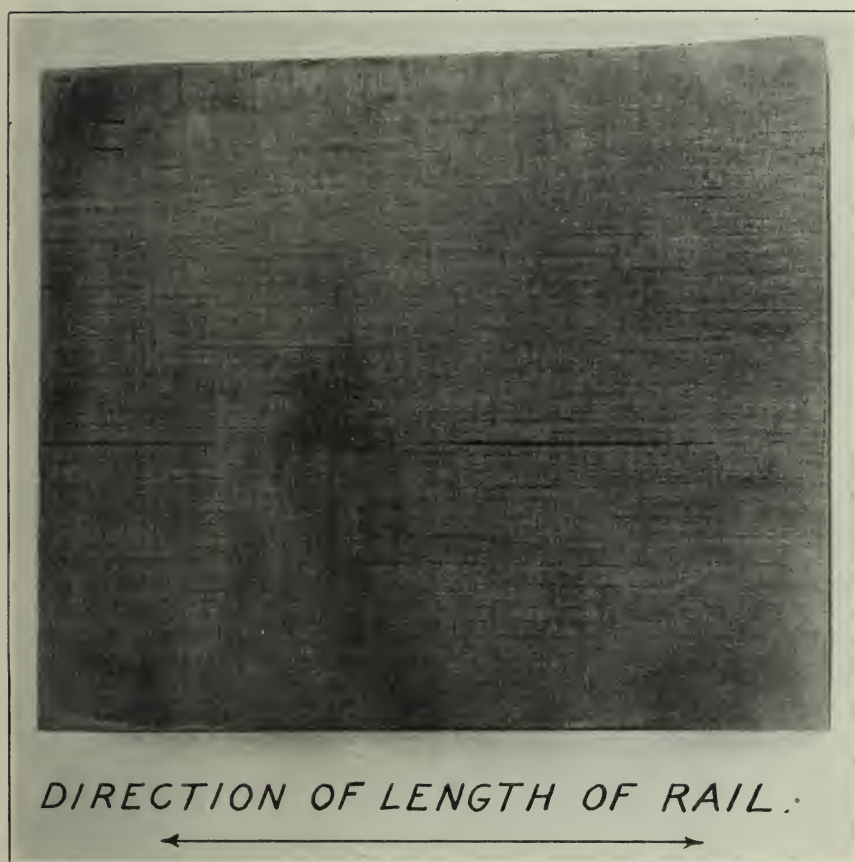
tures were developed, following in general the dark lines which the etching brought into view. Figure No. 10 shows the streaked appearance of the metal of the base, as found at a depth of one-half inch from the lower surface of the base.

No. 10. Strips from base of rail at depth of  $\frac{1}{2}$  inch from lower surface, as shown by figure No. 8. Surface polished, and etched with tincture of iodine, showing streaks in steel.

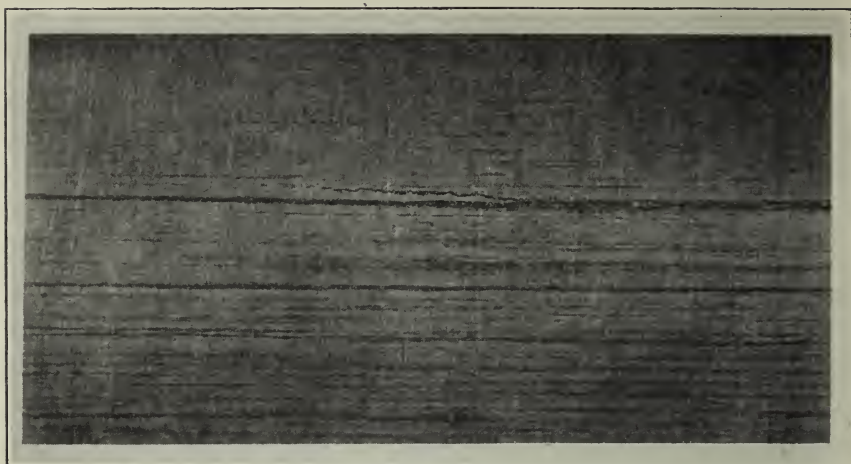
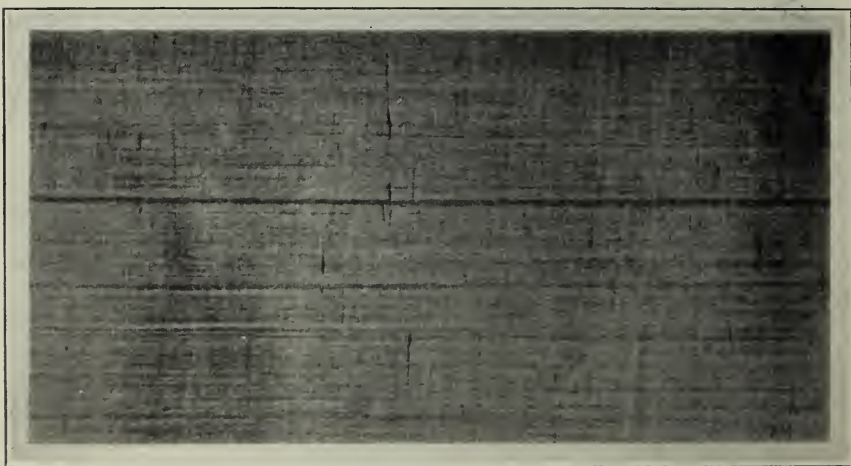
These streaks, which indicate lines of structural inequality, were plainly visible macroscopically and appeared more conspicuous on the etched specimens themselves than the photographic prints show. The slice taken from the head,  $1\frac{1}{2}$  inches below the running surface, was photographed with a magnification of about 3.2 diameters. It was then bent and a line of rupture started along one of the principal dark lines. Figure No. 11 shows the appearance of this slice before and after it was partially fractured by a bending stress.

No. 11. Strip from head of rail at depth of  $1\frac{1}{2}$  inches below running surface of head, polished, and etched with tincture of iodine, showing streaks in steel; magnified about 3.2 diameters. Upper figure before bending; lower figure showing line of fracture made by bending, which followed dark streak in steel.

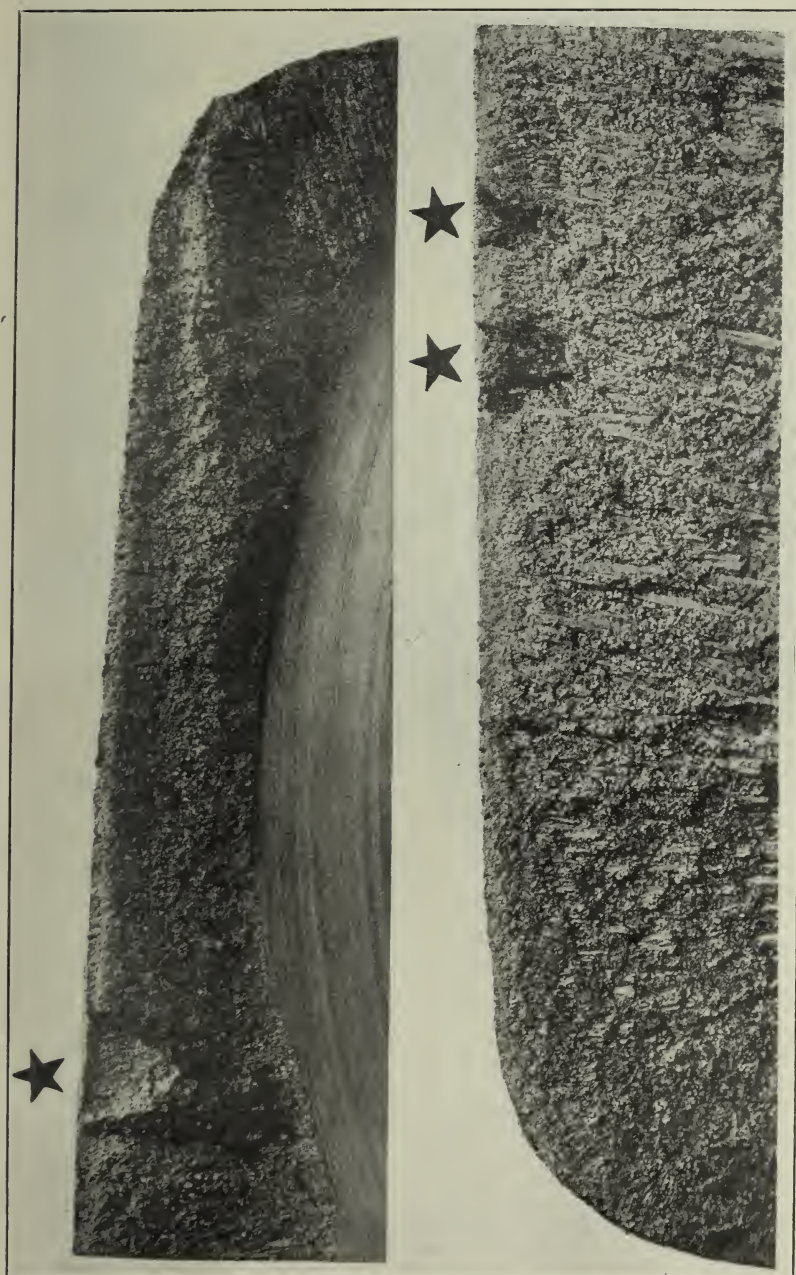
The dark areas shown on the photographic prints, figure No. 12, represent shrinkage cracks extending inward from the surface of the ingot. These oxidized areas would necessarily be located at or near the surface in the finished rail, and cause defects of quite another order from those witnessed in the interior metal of the present rail.

No. 12. Fractured surfaces of rail-steel ingot, showing shrinkage cracks, indicated by stars.
